RED WALL

PROPERTY INSPECTION REPORT

WAYNE GARDNER - OREGON CERTIFIED HOME INSPECTOR

1313 Mockingbird Ln - Portland, OR. 97219

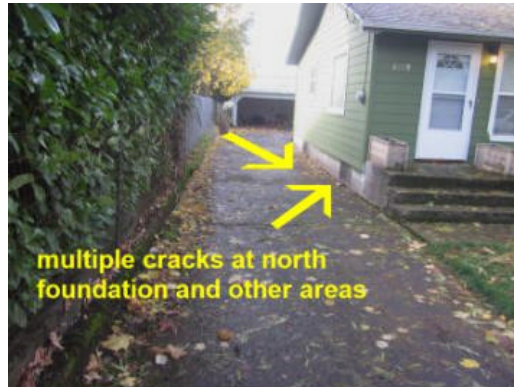
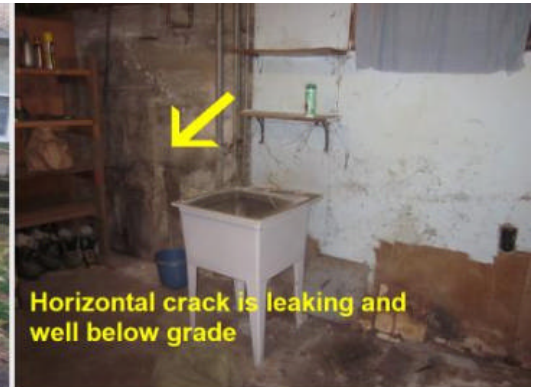
FOUNDATION:

MAJOR CONCERN - Reason: Water at foundation is continuing concern and potential cost of repairs. I noted:

- The basement/foundation walls are cracked in many areas. I also noted multiple horizontal cracking, especially at the north/laundry area where the crack is larger than hairline and is well below grade and along a 'wet' wall. There is some inward deflection in this area. I also observed soil penetrating through the foundation at the laundry area (covered). This is evidence of voids/holes in the lower foundation wall behind the coverings. There is more than a typical amount of cracking present and the water at the exterior side is a concern for future stresses. A drainage solution/improvement is needed and further evaluation of the foundation is recommended. Have a qualified engineer review the foundation further, while you are still within your inspection period.

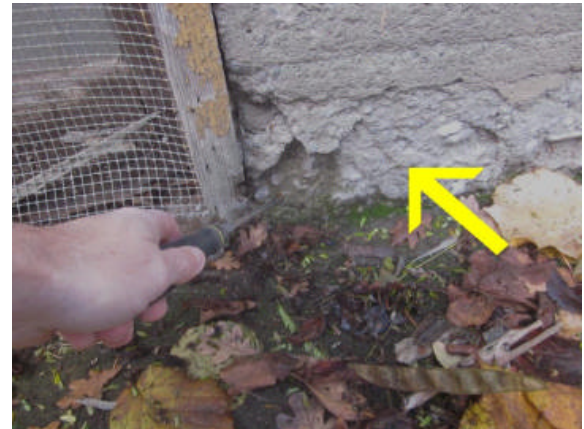
SKIM COATING:

There is deterioration of the outer surface of the foundation. Have a foundation contractor review and patch/skim/repair as needed to protect the foundation from further deterioration.

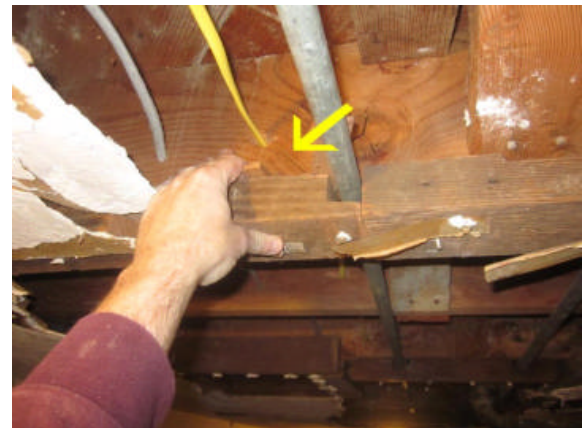
FLOOR STRUCTURE:

I noted 2 cracks in the floor joists (visible from basement). There may be more. The cracks I noted were created when holes were drilled for wiring near knotty areas. You should reinforce or repair these areas.

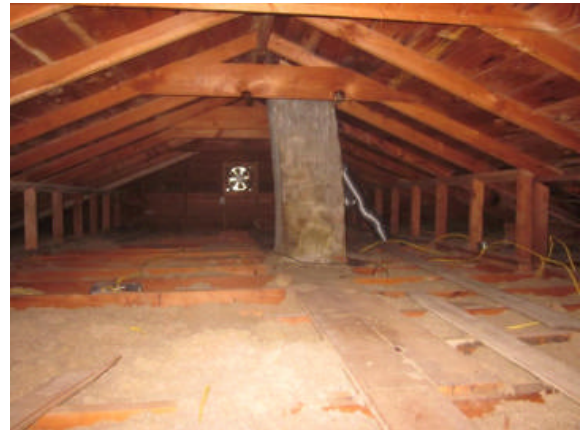
ROOF STRUCTURE:

Photo of general roof structure.

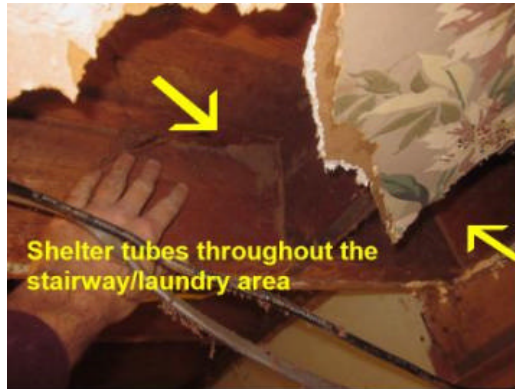
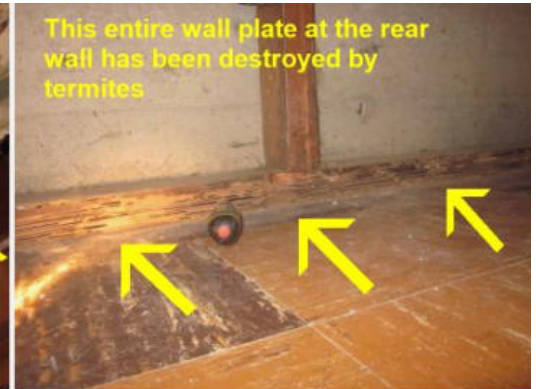
WOOD DESTROYING INSECTS:

MAJOR CONCERN - Reason: Potential for hidden damage and cost of treatment. There is evidence of past and/or present wood destroying organisms/pests in this home. I observed Termite damage in many basement areas (see the WDO report). I also observed live termites during the inspection. My evaluation is non-destructive, meaning I cannot look inside walls, floors, and other covered areas. There is a potential for hidden insect infestation and damage. I cannot protect you from this condition. Only further evaluation by qualified contractors can determine the extent of the activity and damage. While you are still within your inspection period, I recommend you have qualified contractors perform further evaluation and apply proper pest treatments as needed and as recommended by the Oregon Department of Agriculture.

- The area behind the front entry stoop is very susceptible to termite damage. My review was limited in this area today.

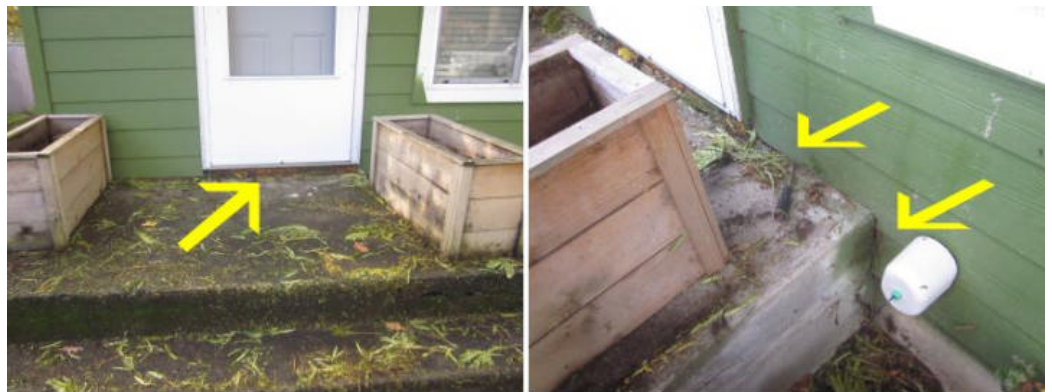
SIDING:

The siding is generally serviceable with the following notes & recommendations:

- The areas below doorway thresholds are unfinished and open to water entry and damage. Spray foam is not meant for use in wet areas. There is potential for hidden damage and pest infestation in these areas, especially around the front porch area. Review and repair these areas.
- The wood lap siding at the rear roof area is loose and is poorly painted. Secure and paint properly.
- The siding joints require periodic caulk maintenance to minimize the amount of moisture which can enter behind the siding. Today I observed many siding butt & trim joints which are in need of

- The area where the front stoop meets the house is open to moisture, making this area a very conducive condition for wood destroying pests and rot. Review and protect this area from moisture.

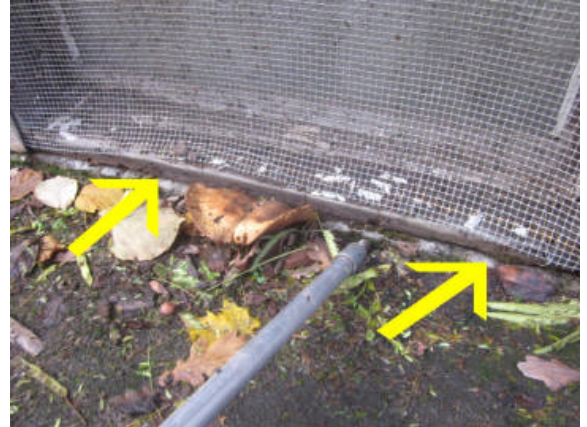
- Significant rot and pest damage/infestation observed at 1 or more basement windows. All damaged material must be removed and repaired.
- Peeling paint and bare wood are visible at window frames. Keep all windows and wood frames properly painted to help prevent decay.
- Window wells are needed at one or more windows. Install where needed.

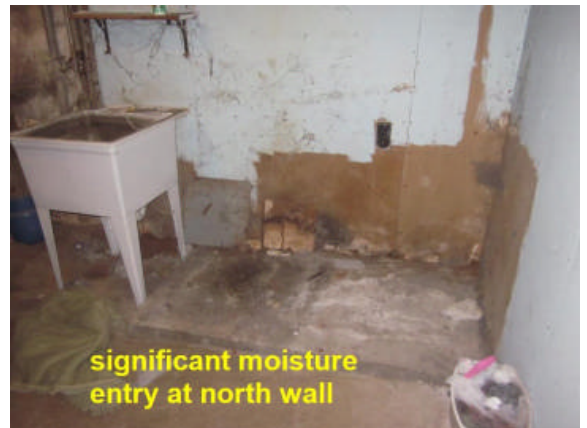
FOUNDATION DRAINAGE:

MAJOR CONCERN - Potential cost for repair. I noted the following:

- The home has a wet basement. Upon entering the home I noted a musty odor. This is not typical.
- Water is directed to the home from the south. The driveway is flat or slightly negatively sloped to the foundation and allows much of the water to reach the south foundation. Today, large mushrooms were observed growing in the joint between the home and the driveway.
- There is visible heavy water entry at the south wall and evidence of less chronic or past water entry in other areas.
- Grading, especially at the rear of the home, also directs water to the foundation.

Recommend further evaluation by a drainage contractor.

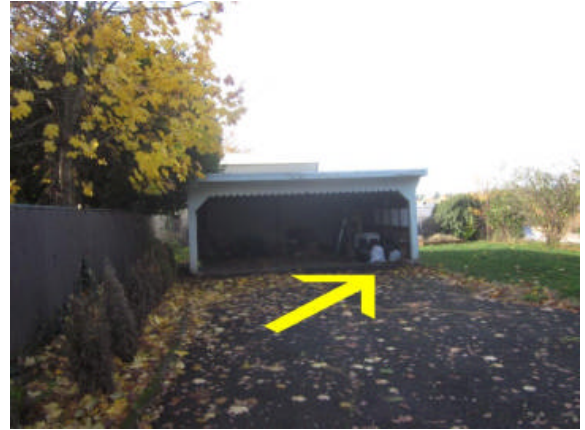
DRIVEWAY:

- The concrete section is cracked and settled. Trip hazards are developing and water is being directed to the foundation. Removing/repairing the driveway is most likely part of the needed drainage repair around the home. This is not insignificant.
- The asphalt section is badly cracked and settled. Repairs are needed. Also, the upper section of the driveway directs water to the front, north corner of the parking structure and as a result, the foundation of the parking structure is failing.

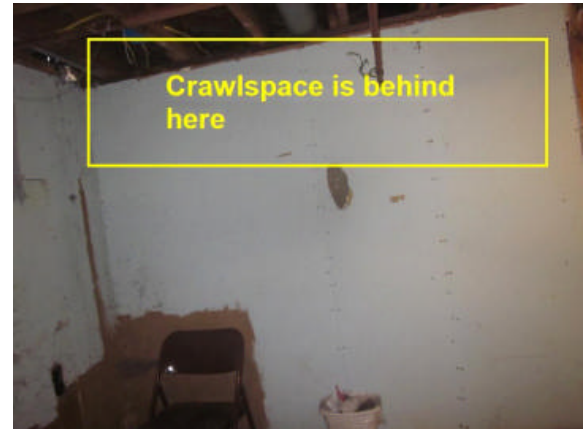
CRAWLSPACE ACCESS:

There is no access to the crawlspace. Have proper access created and contract with myself or another qualified contractor for further evaluation while you are still within your inspection period.

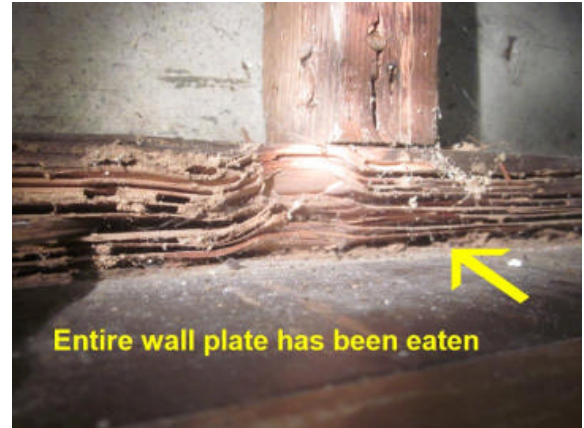
MAJOR CONCERN - Reason: Potential for hidden damage and high cost of repairs. I observed:

- Evidence of past and present termite damage is present throughout the basement. This home will not receive a clear Pest & Dry rot report from this company under current conditions. See the WDO report for more information.

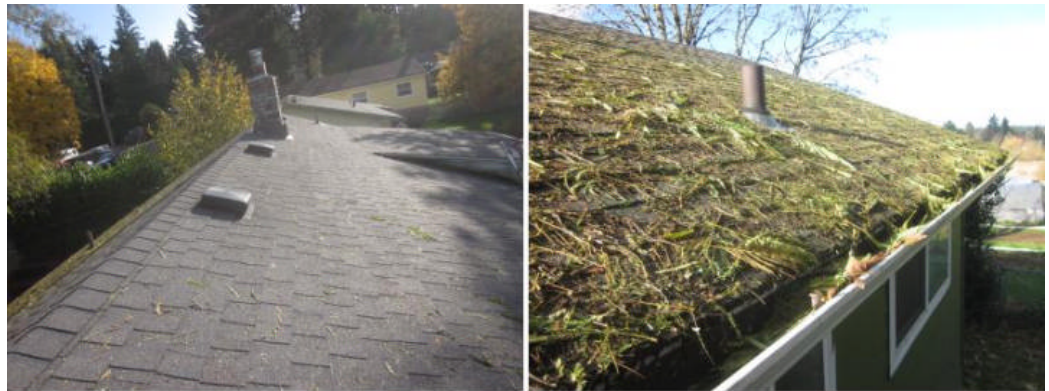
MAIN HOUSE ROOF:

Today I observed the roof to be in typical condition for its age. I observed the following needed repairs:

- There is heavy debris/moss on the roof. The roof needs to be cleaned by a professional. Once cleaned, have these areas reviewed for needed repairs. I could not review them properly today.

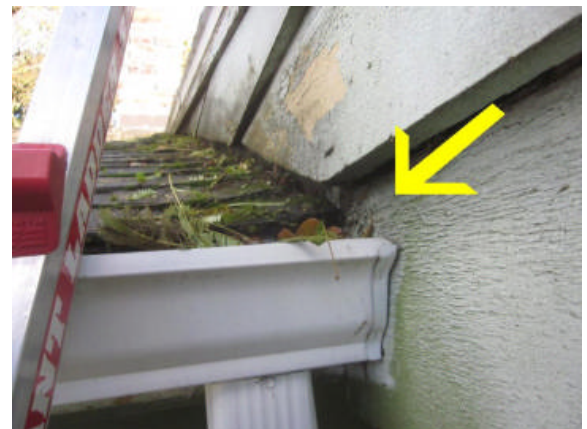
KICK-OUT FLASHING:

There was little or no kick-out flashing observed. Kick-out flashing is needed at areas where a roof terminates along a vertical wall. The job of the flashing is to 'kick' the water into the gutter at the bottom edge of the roof instead of letting it run down the siding below. If the flashing is missing and water does run down the siding below, damage can occur. You should have your roofer review these types of areas on this home and install the flashing where it is needed.

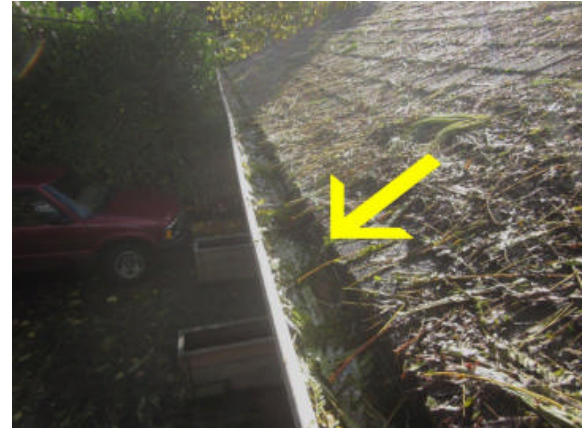
GUTTERS:

I observed heavy debris and standing water in some or most gutter areas. Clean the gutters and test them for proper operation. Adjust/repair as needed.

- The gutters are difficult to evaluate in this condition.

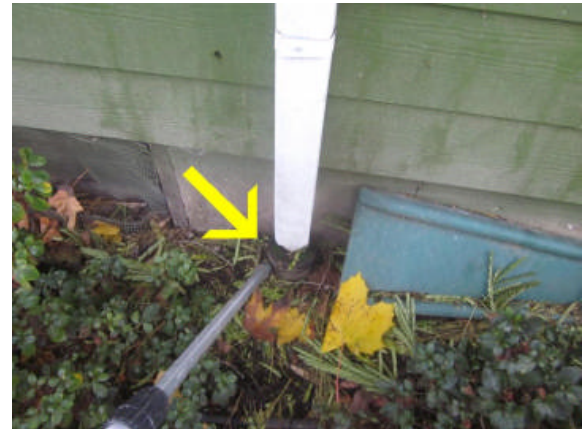
DOWNSPOUTS:

Poor/restricted connection observed at the front middle of the home. Repair the gutter/underground drain connection.

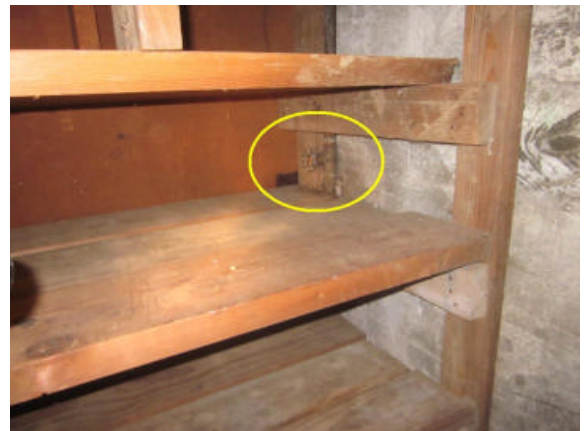
WATER SHUT-OFF:

Picture of shut-off in basement.

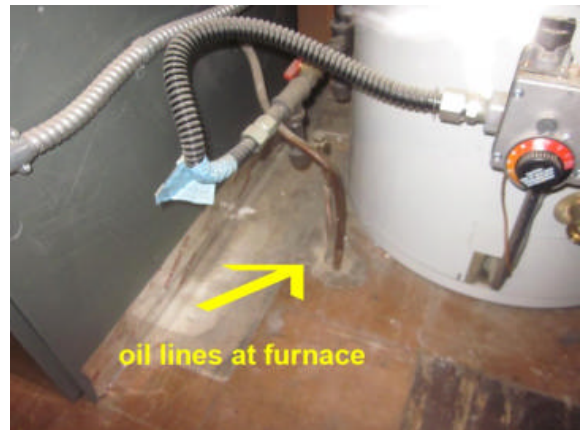
OIL TANK:

CAUTION - There is evidence of a buried oil tank on the property. Buried oil tanks are beyond the scope of this evaluation. Further evaluation and soil testing by a qualified expert is recommended before you purchase this property. A leaking oil tank can potentially be a costly environmental hazard.

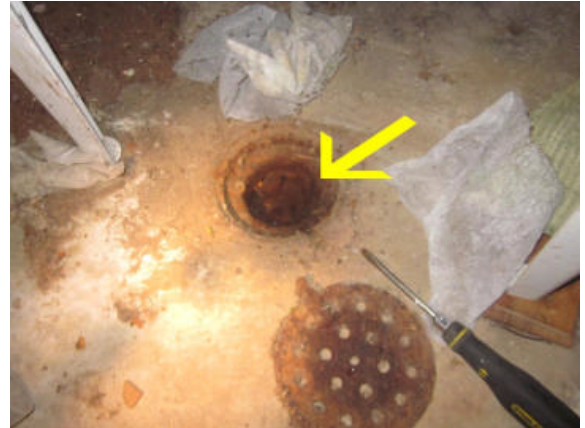
FLOOR DRAINS:

The basement floor drain is not functional. It appears to be blocked by a corroded steel pipe/plug. Recommend further review by your plumber.

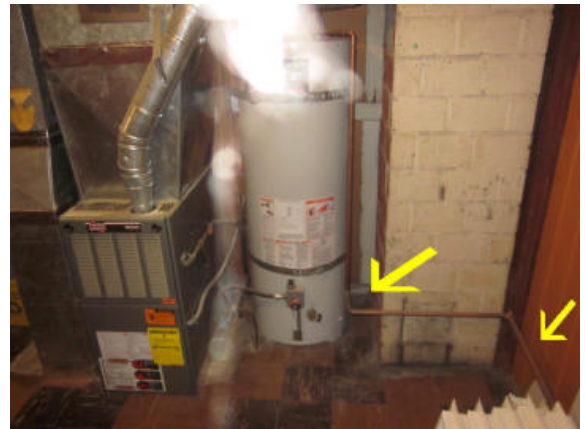
SAFETY RELIEF VALVE:

CAUTION - The TPR pipe is installed in an improper manner. The TPR pipe is a safety feature and water should only discharge in the event of a water heater failure. You should have the piping installed in a simpler manner so that it discharges onto the concrete floor at the base of the unit.

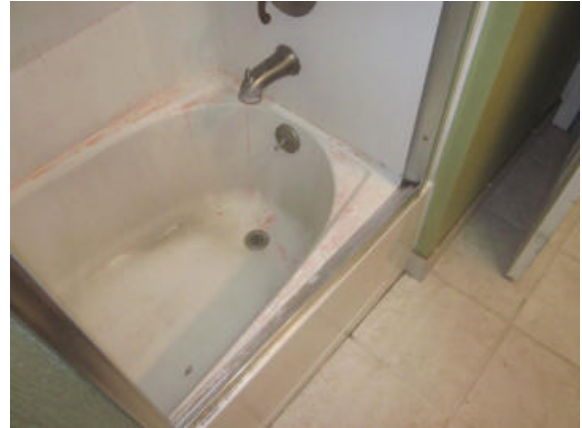
BATHTUB(S):

The bathtub is badly stained. I cannot tell you if this staining can be removed.

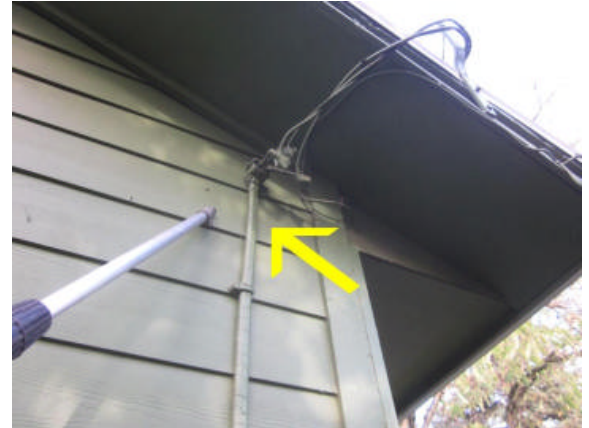
I noted the following:

- Service wiring is unprotected along the south siding and is wearing/fraying. Future replacement of this wiring will be needed. Have your electrician review.
- The service wiring is in the trees and can be damaged. Have the tree trimmed by a professional and have the wiring repaired as needed.

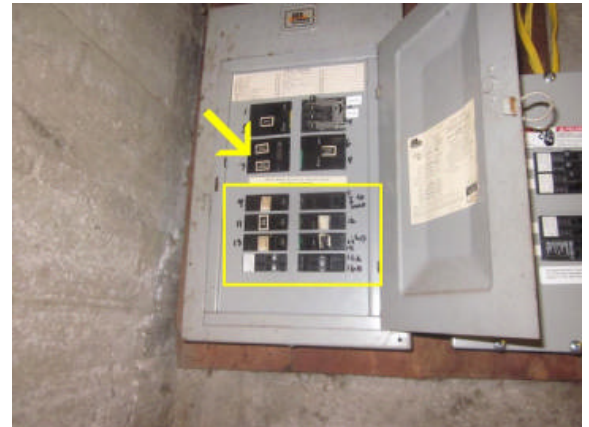
SERVICE DISCONNECT:

Picture of main disconnect at panel.

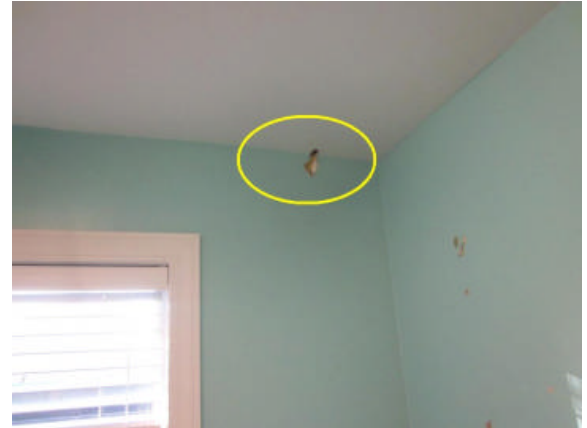
- Work has been performed to upgrade/add to the wiring in the home. There is new wiring present at the kitchen/dining nook ceiling which is unprotected and over the studs.
- Missing clamps at junction boxes (attic & basement). The wiring is subject to damage at the sharp edges of the boxes.

This is evidence of non-professional work. Have your electrician review the wiring in the home and make the needed repairs for safety.

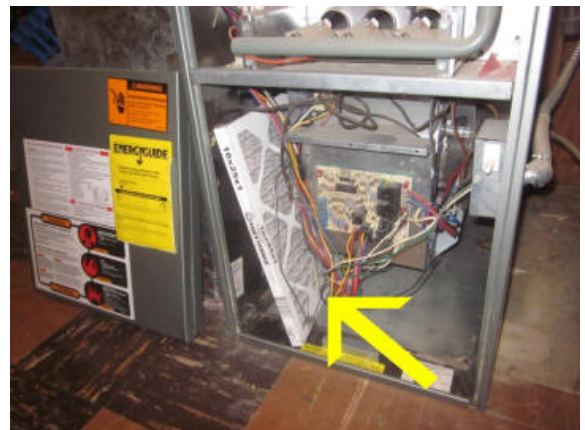
I noted:

- The filter or filters are out of place. They are not secured properly or they are installed improperly. The result is dirty air is reaching the blower. Have proper, clean filter(s) installed and have your furnace/blower cleaned as needed.
- The filter is very dirty. Replace the filter.

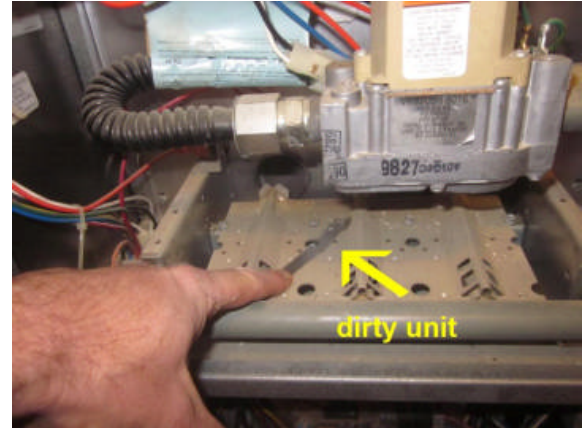
GENERAL CONDITION:

Although the system generally operated today, I noted the following concerns:

The unit is in need of servicing. As noted above, there are also recommended repairs. Have your HVAC contractor review, service and repair the unit as needed.

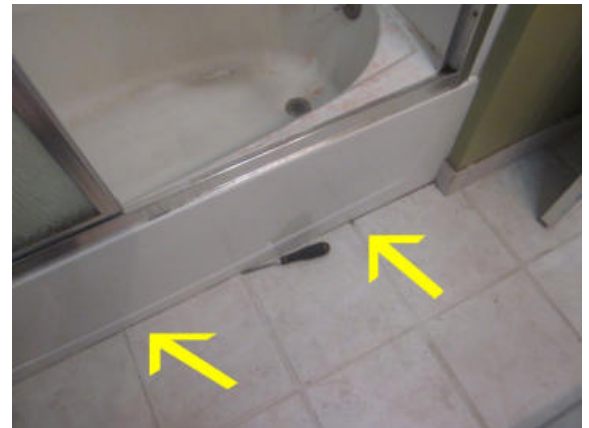
BATHROOM FLOORS:

The caulking at the joint at the base of the shower/tub and floor area should be improved to minimize moisture entry.

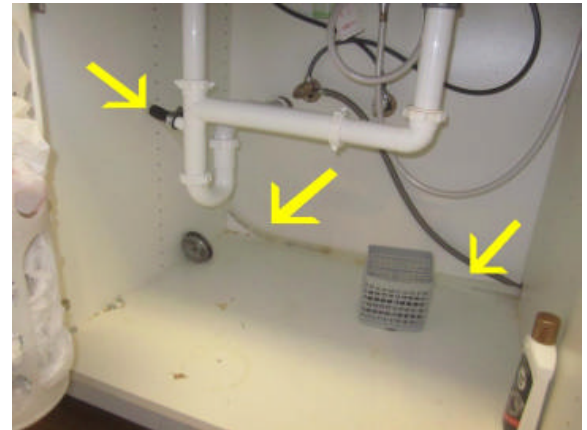
- There is no high-loop installed in the dishwasher drain line. The high-loop is achieved simply by using a metal clip or tie to secure a portion of the drain line to the rear cabinet wall at a height greater than the point where the drain line exits the drain connection. The elevated sections helps to prevent back-siphoning of dirty water into the potable water supply system. You should install the high-loop.
- The drain line is also crimped where it attaches to the drain. Reposition for best operation.

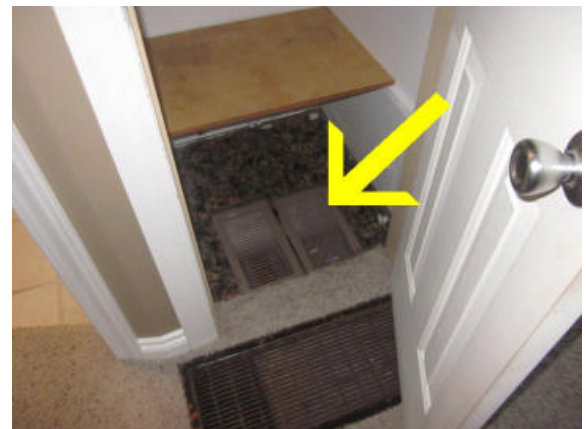
- **CAREFULL!** This chute is more dangerous than most. I'm not even sure I would describe this as a laundry chute. It is really a large, very accessible hole in the floor.

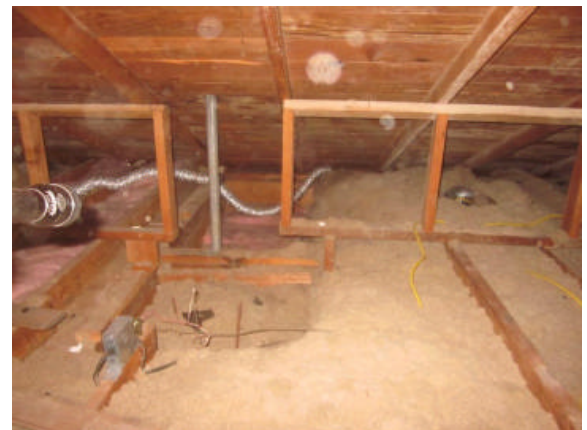
ATTIC INSULATION:

- I would estimate about 4 inches of insulation covers most areas of the attic. Some of it has been compacted from storage. This is below modern standards. You can improve the comfort and efficiency of the home by adding insulation to the attic.
- Small areas of missing insulation were noted. You should add more insulation in these worn/missing areas to restore the R-value.

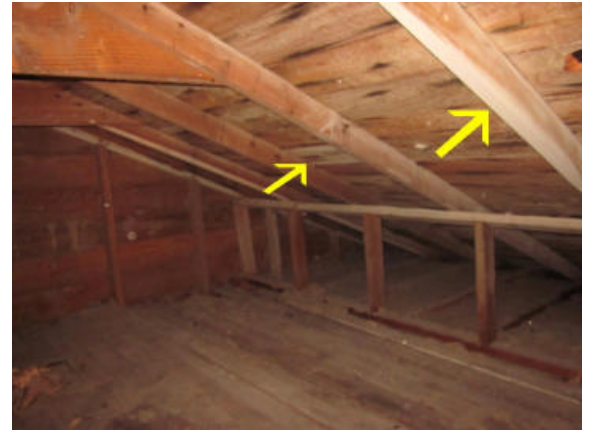
ATTIC VENTILATION: There is minimal eave venting. I observed far less than the recommended amount of eave ventilation. Some of these vents are small and are mostly painted over, making them even less effective. Have your contractor

You should consult with qualified experts and contractors in this area.

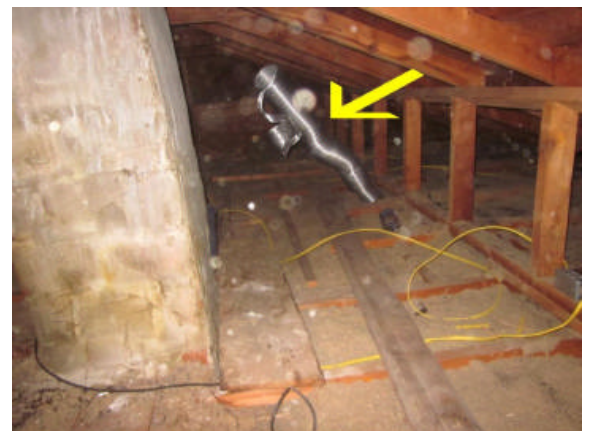
KITCHEN FAN/VENT:

- The fan is simply discharging into the attic. A proper vent, designed for use as a kitchen vent should be installed in the roof above the area and an air tight connection made using smooth metal venting. Avoid using corrugated material.
- The vent line for the kitchen fan is made with a flexible, corrugated line. Solid metal vent line with an air-tight connection to a roof vent, designed for this application, is preferred. The corrugated line is likely to trap moisture and will not work as well as a proper line. Have your contractor review the installation and improve.

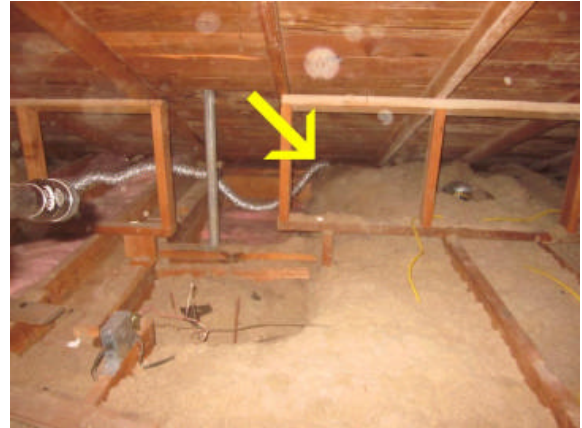
BATHROOM FANS/VENTS:

There is a bathroom vent installed but it appears to be discharging at the eave. All vents should discharge through roof vents and not eave vents. Air naturally enters the attic through the eave vents and any moisture being exhausted outward at the eave is typically blown back into the attic area, often resulting in high moisture conditions at the eave and inside the attic in general. Have your contractor review and properly vent all fans to discharge through roof vents. Repair and moisture damage found.

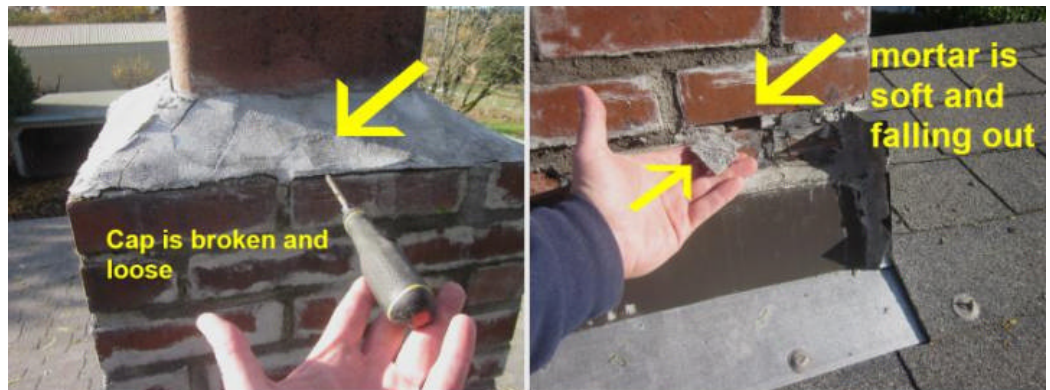
UTILITY CHIMNEY:

The chimney has been recently repaired. I noted the following:

- The new cap is badly cracked and is loose. It is already falling off.
- The mortar has been tuck-pointed but the work appears unprofessional. It is soft and has already fallen out of some areas.
- The flashing is loose in some areas.

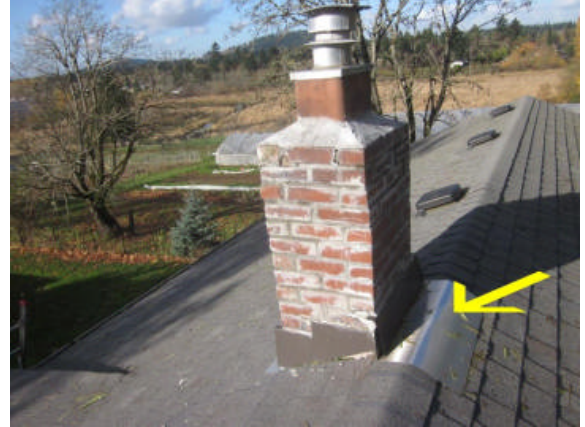
The flashing (see photo) observed. This piece is just sitting on the roof loosely. Repair/secure the flashing.

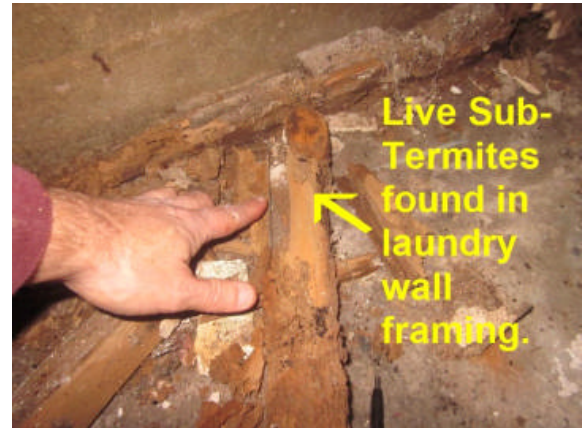
SUBTERRANEAN TERMITES: **YES. ACTIVE.** Further evaluation and treatment recommended at this time. Mud/shelter tubes and damage observed at framing around and under rear stairway platform, at laundry wall area, and along rear basement wall. There is likely activity and damage which I did not find today. I observed live termites in the wall framing in the laundry area.
