## PROPERTY INSPECTION REPORT

123 Main St - Portland, OR . 97000

**DATE OF INSPECTION:** 02/25/2011

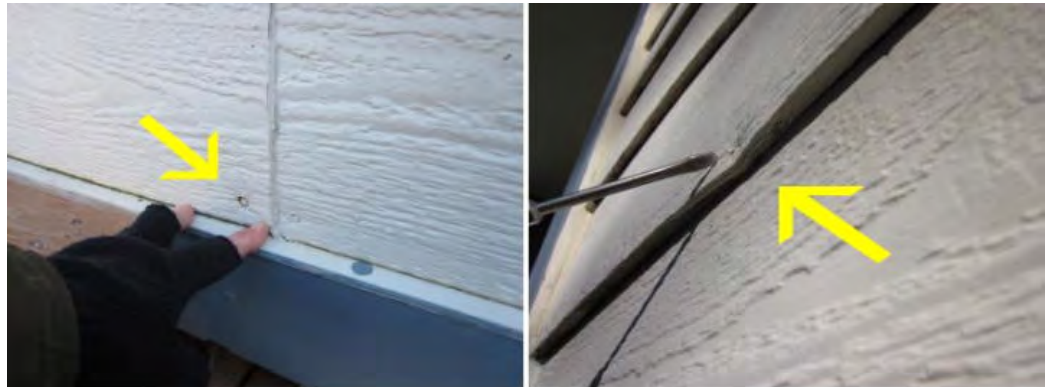
**SIDING:**

**MAJOR CONCERN** - Due to the potential cost for residing the home, this is a Major Concern. See below. The cladding on the home is a composite type and it is consistent with the composite siding manufactured by Louisiana Pacific (LP) in the early/mid 1990's. This type of siding is known to be prone to moisture absorption issues and may have been part of a class action law suit. To my knowledge, the law suit has ended and there is no longer funds available from the manufacturer. You should investigate this for yourself as my information may be incorrect. In my experience, most of this type of siding has been replaced by this time.

**CONDITION:** I was surprised to find the siding in relatively serviceable condition. Make no mistake, there are several areas where moisture absorption is occurring and the siding is in a state of break down but is generally performing as siding should. These areas are most prevalent on the south and west sides of the

home. I observed the worst areas at upper level butt joints. See the photos for the areas I am describing.

**RECOMMENDATION:** You should plan to have the siding replaced. You should contact a qualified contractor to review the siding and provide you with pricing for replacement. Until replacement occurs, keep the siding and joints well caulked and painted to slow/minimize the damage as much as possible.

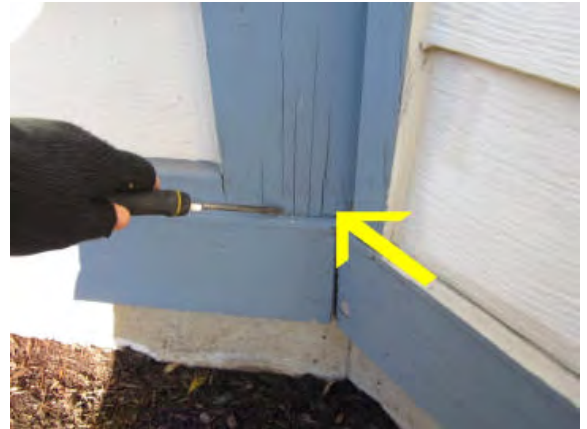
## **TRIM:**

I noted peeling paint at trim areas. You need to ensure all wood surfaces are properly painted. When wood is left bare, rot and decay begins.

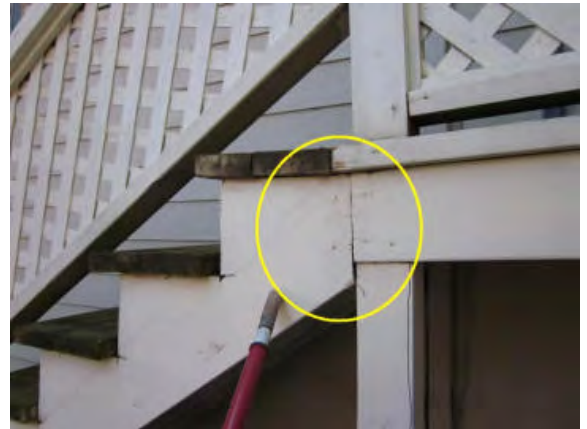
## **STOOPS & STEPS:**

**CAUTION** - The rear entry steps have several concerns. The steps are not well attached to the platform (weak connection). The platform is not well attached to the house and is not flashed to prevent damage to the siding or interior walls. Have a qualified contractor review the stairway and repair it as needed.

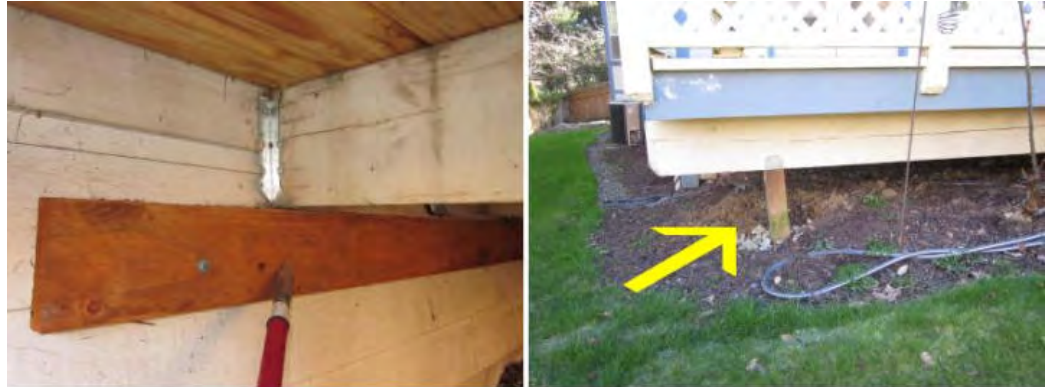
## DECKS:

**MAJOR CONCERN - CAUTION** - The deck is poorly attached to the house. The joists are attached directly to the composite siding with undersized hangars. Someone has half-hazardly installed a ledger board, over the siding, below the joists. It is ineffective. There are also angles pieces of wood attached to joists to improve support. An exterior side post was also recently replaced and it is not vertically plumb. Overall the deck is in danger of becoming detached from the house and falling and it is also a threat to damage the siding. Have a qualified decking contractor review and repair the deck properly.

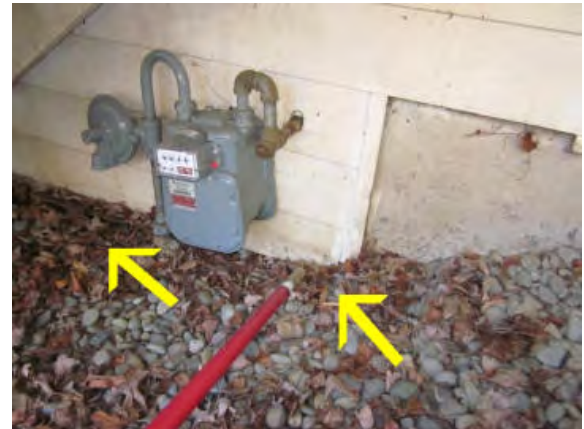
## GRADING:

The grade at the foundation is too high in some areas (Front of garage foundation and near gas meter under the rear steps). Where the grade is high, you need to lower it to expose as much foundation as is possible (6 inch minimum is recommended) without creating low areas for water collection. In cases where it is difficult to adjust the grade without creating water drainage problems, you may need to consider some form of underground drainage in conjunction with the grade adjustments. In cases where the siding is in contact with the grade, you may need to perform some siding repair.

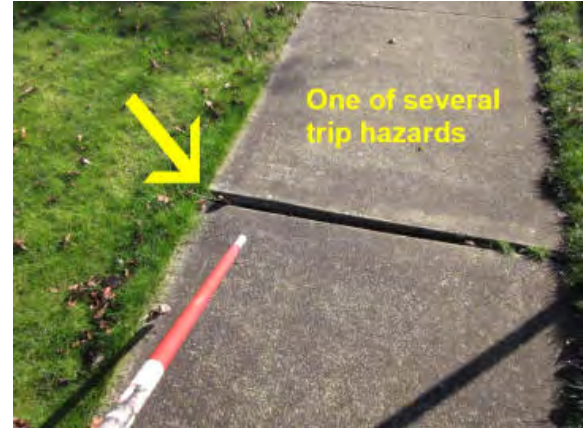
## PUBLIC WALKWAYS:

**MAJOR CONCERN** - The sidewalks are damaged/settled and are in need of repair. There are several lifted sections which now present trip hazards to pedestrians. It appears trees are the culprit and tree removal may be part of a long term solution. This increases the cost of the repair as an arborist should be consulted also. You should know that sidewalk repairs are generally the responsibility of the homeowner and repairs should be made when a sidewalk presents a hazard to pedestrians.

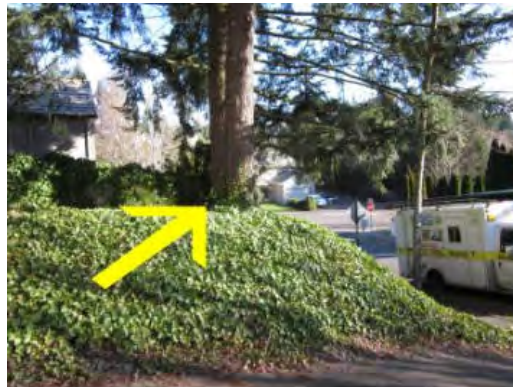
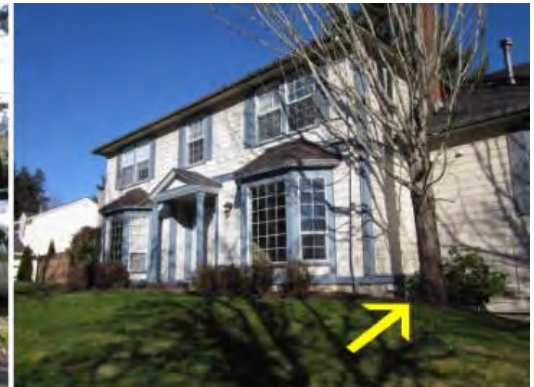
## LARGE TREES:

There are 2 issues to consider in the future:

- There are 2 very large pine trees at the NE end of the driveway which are atop a slope which shows evidence of movement to the down hill side. Although the trees were straight up and down today, there is a chance they could also begin to move down the slope in the future.
- There is a large tree very near the home at the front. Keep them well trimmed to prevent damage to the roof and siding. These trees also assist animals in accessing your roof. If found to be a problem, consult with an arborist for recommendations.

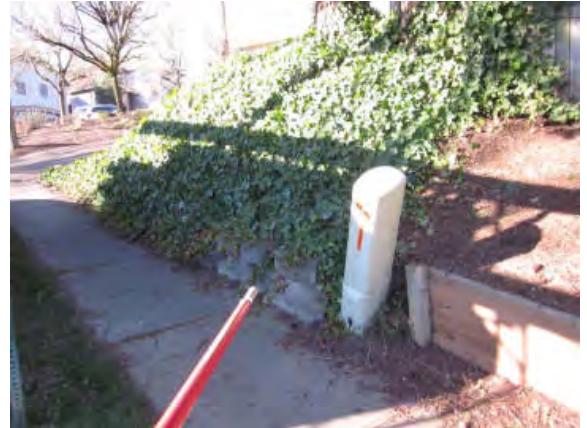
**SLOUGHING GRADE:**

The grade on the north side of the drive is sloughing or moving downhill. It is pushing over the block wall under the ivy and it is pushing over the telephone connection box. I'm not sure if you would be responsible for the telephone box repairs or not. You will need to repair the wall while you live in the home. You should plan to consult with a qualified contractor to repair the damage and secure the grade in the area to better prevent any further movement.

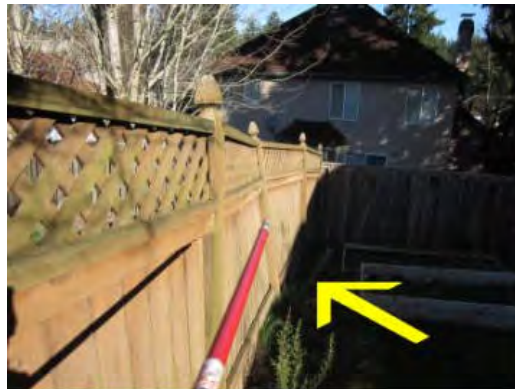
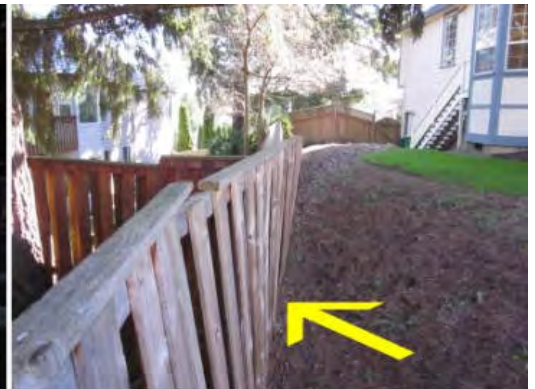
**FENCING:**

The fence around the home is damaged in multiple areas, including the west and north sides. It is time for repairs/replacement of much of the fencing.

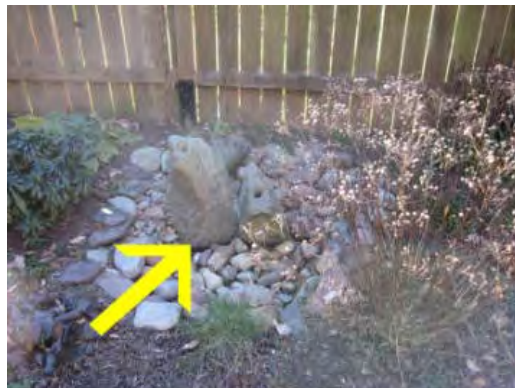
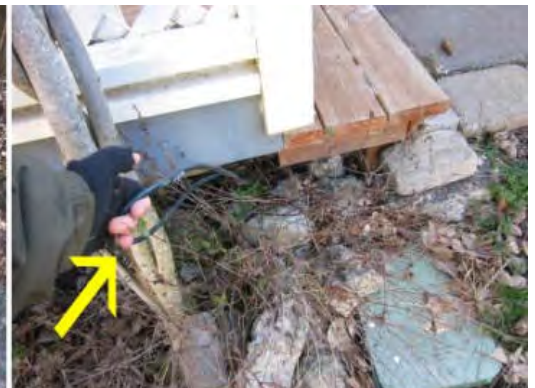
**HAZARDS:**

There is a water feature at the south fence area. I don't know if it operates or even if it has electrical power to it. There is an electrical cord under the deck but I don't know where it goes. If in fact the fountain does use electricity, have your electrician review it and install proper wiring as needed.

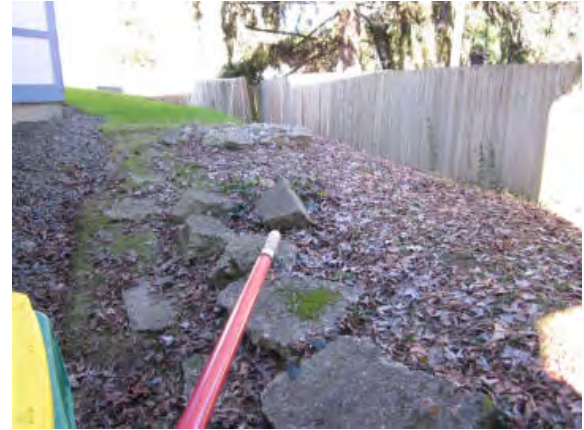
**CAUTION** - There are large pieces of broken concrete in the back yard. There are several sharp edges. Consider having this material removed.

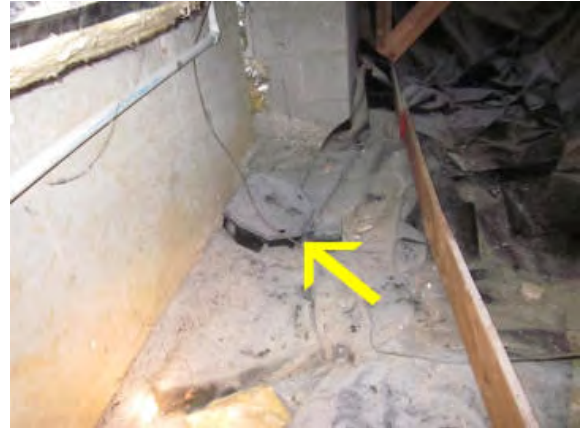
NOTE: There is a rodent bait box behind the garage wall, in the crawlspace. This is evidence of past/present activity under the home. These bait boxes are typically part of a subscription type treatment with a pest contractor but I did not see a label on the box. Have your pest contractor review the home for rodent activity and recommend treatment. \*As far as the attic goes, I did not see evidence of rodent activity in the attics today but that does not mean there isn't any. Include in the recommended pest review.

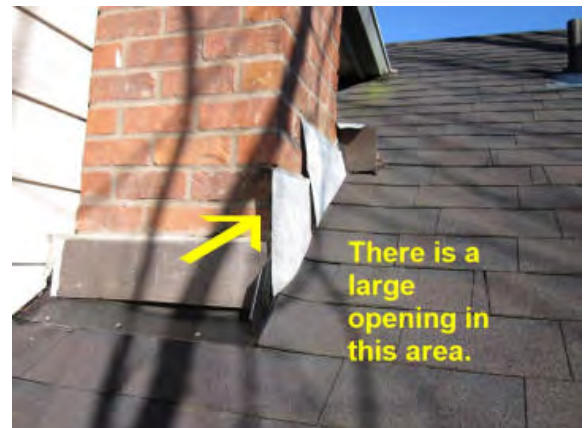
The counter flashing at the chimney is open to wind blown rain. You should have a masonry contractor improve the flashing around the chimney to minimize the opportunity for moisture intrusion.

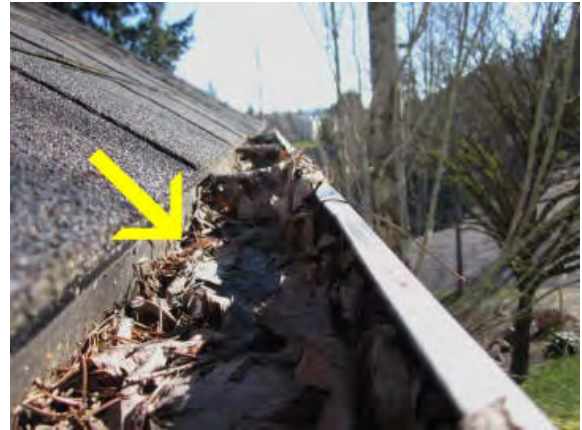
**GUTTERS:**

I observed heavy debris in the accessible gutter sections. Cleaning is needed. Have a contractor clean the gutters and ensure they are operating properly.

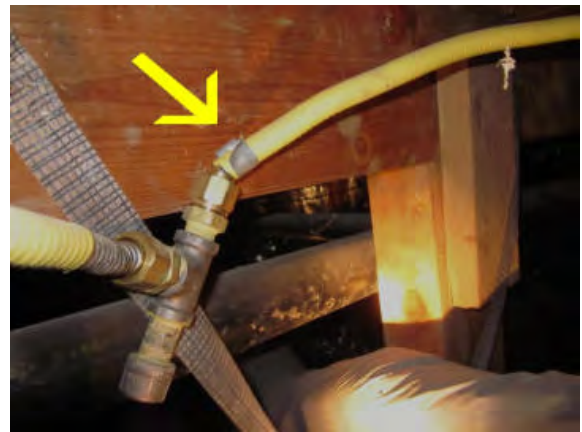
## GAS PIPING:

There is a loose gas line clip in the crawlspace, under the range. Secure the clip properly.

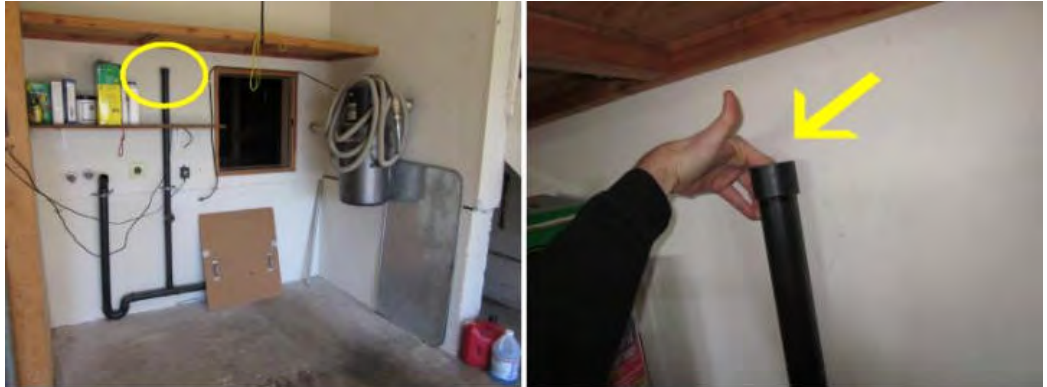
## DRAIN/WASTE/VENT PIPING:

Garage Laundry: The home owner installed piping for a laundry in the garage. The vent piping was never completed properly and is open and allowing sewer gas to enter the garage. Have a plumber review and repair it.

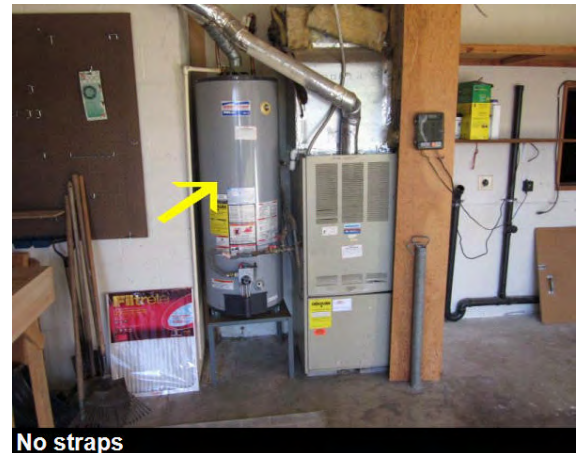
**CAUTION** - The water heater is not strapped in place to protect it from moving during a seismic event. Have the water heater secured in place using 2 metal straps at the upper and lower third sections of the tank. If there is a single strap present at this time, a second strap should be added.

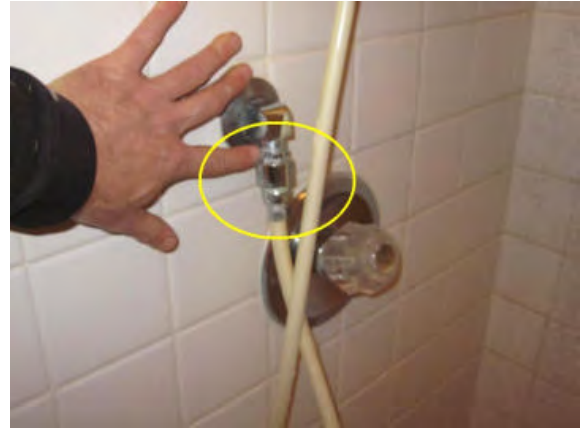
The shower line connection, in the master bath, is leaking. Remake the connection properly.

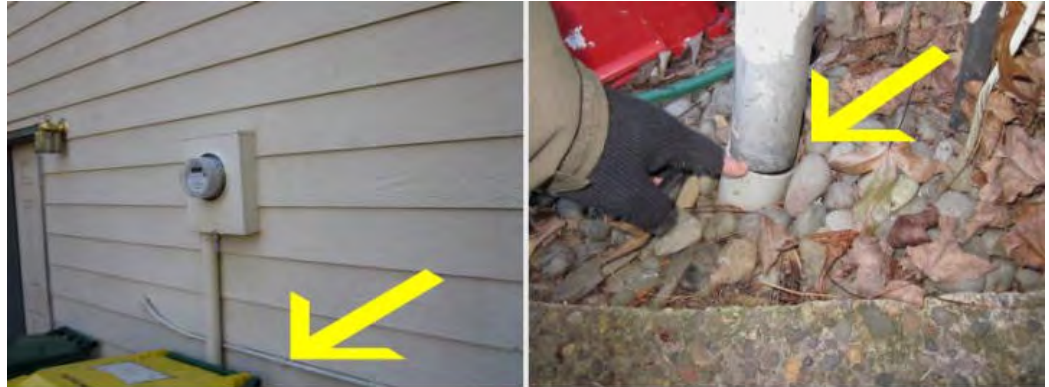
**UNDERGROUND SERVICE:**

**MAJOR CONCERN** - Due to settlement at the base of the conduit, the protective conduit is coming apart. This is a major concern because this repair can be costly as the electrical service may have to be disconnected. Have your electrician review and repair the conduit for safety.

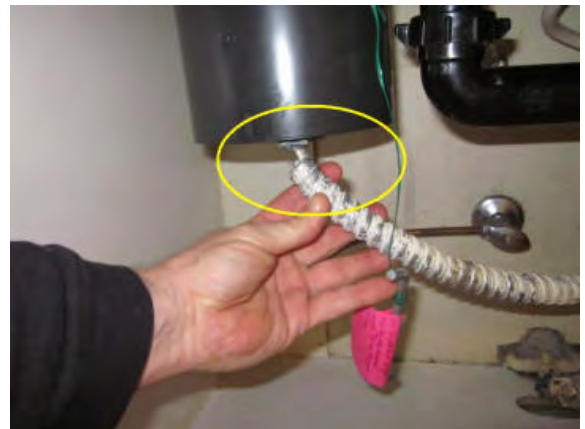
**DISPOSAL WIRING:**

The wiring at the base of the disposal is a potential hazard. It is not properly clamped/secured at the base of the unit. The wiring could be easily pulled from the disposal unit and become hazardous. Have the wiring repaired.

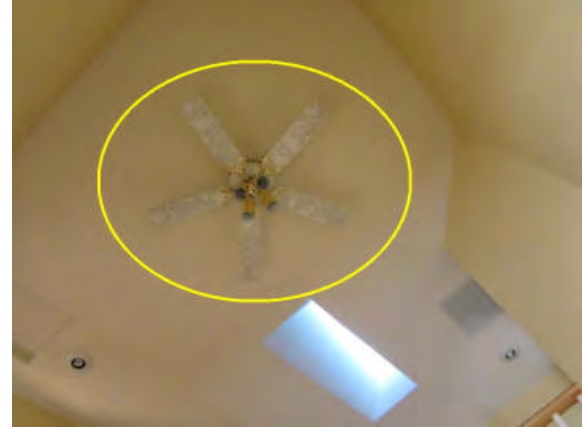
- Some of the lights in the home did not operate today. Have all the non-working bulbs replaced and repair the lighting further as needed. \*One of the lights over the master shower.
- The fan/light, high over the entry foyer, did not operate today. The mounting of this fan also appears suspect. Have your electrician review and repair it as needed.
- At least 1 of the garage lights are not properly attached to the ceiling. Repair/secure the light.

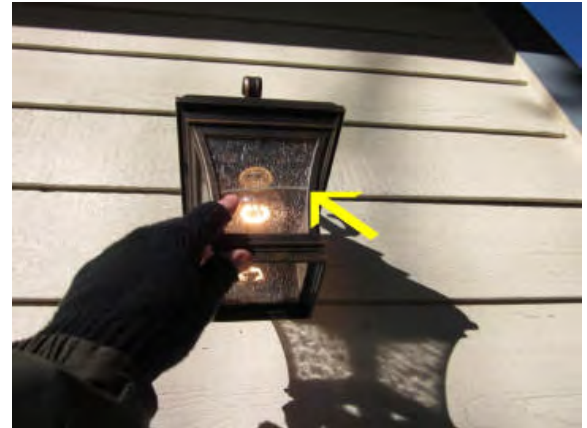
## EXTERIOR LIGHTING:

- The glass in the garage light (north side of door) is broken. You should have it replaced.
- I found several loose light fixtures at the exterior. Have your electrician review and secure them properly.

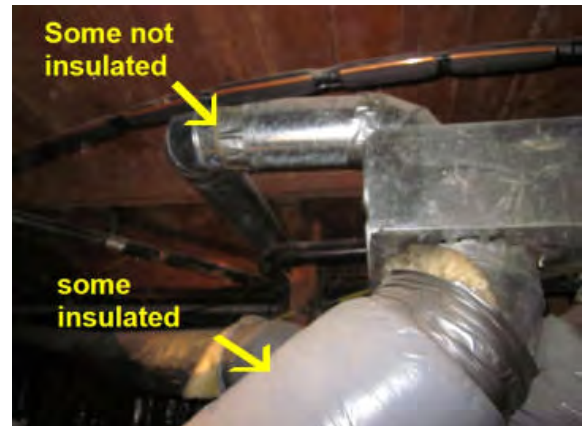
- The metal sections of ductwork under the home are not insulated. You should have them insulated to improve the efficiency of both heating and cooling.
- The ducts are dirty. Consider having them professionally cleaned.

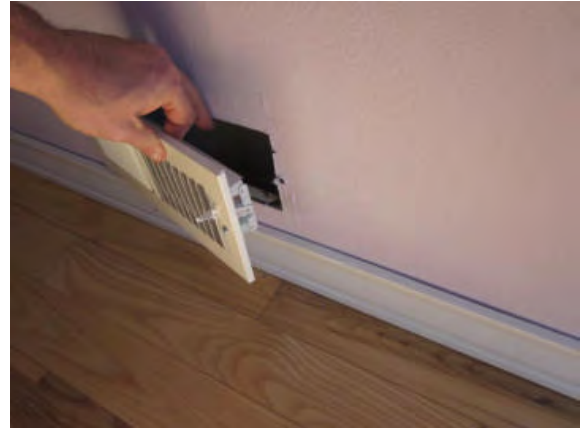
### DAMAGED DUCTWORK:

Loose register covers observed in upper shared bath and in SW bedroom. There may be others. Secure/repair all covers.

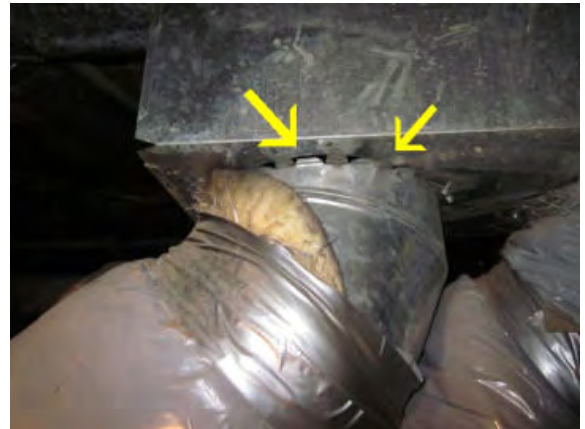
### DISCONNECTED DUCTWORK:

There is a gap where the ductwork meets the branch line in the crawlspace. Have the connections repaired to prevent air leakage.

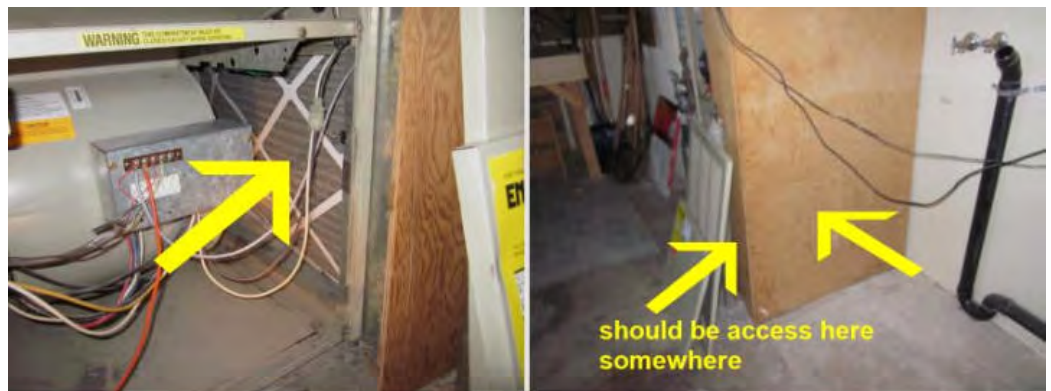
### FILTER:

The filter is not properly accessible. The cover/opening appears to have been covered by the wood face at the front of the return line (next to the furnace). I did not observe any easy way to properly remove/replace the filter. Include in recommended review.

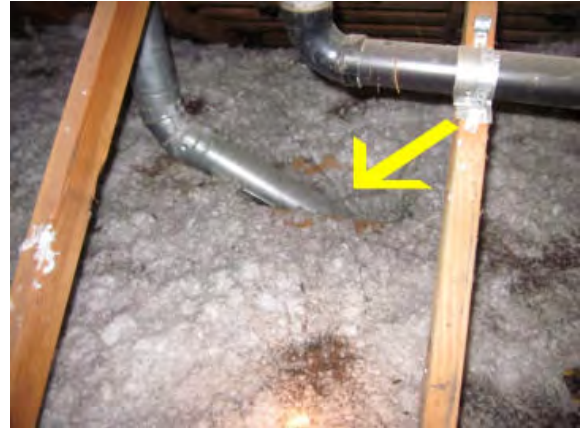
**VENTING:**

The metal vent pipe is in contact with insulation as it goes into or through the attic. Insulation is considered a flammable material in this case and as such, there should be no contact with the metal vent pipe. Clear away the insulation in these areas and install protective metal barriers to help keep the insulation away.

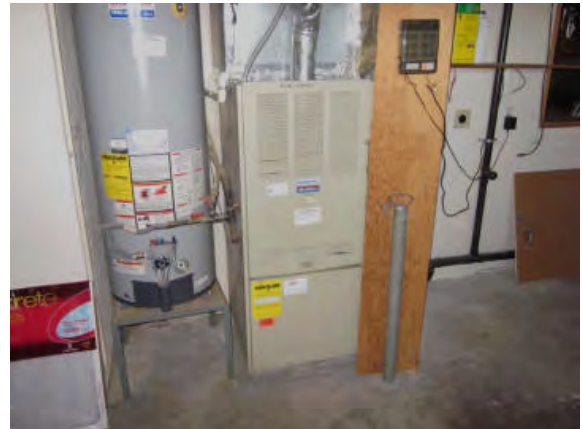
**GENERAL CONDITION:**

**MAJOR CONCERN** - This is an older furnace. It has reached it's typical life expectancy and is still in operation. The main concern is the SAFE operation of the unit as heat exchangers typically fail by now, as noted above. Before you buy this furnace, have it fully evaluated, cleaned and tuned (if found safe to operate) by a qualified HVAC contractor. You should also ask the HVAC contractor for information regarding the remaining life of the unit and cost for replacement. Plan you budget accordingly. You should be prepared to replace the unit at any time. It should also be serviced prior to every heating season at this point.

Also - Front cover is bent and does not fit properly.

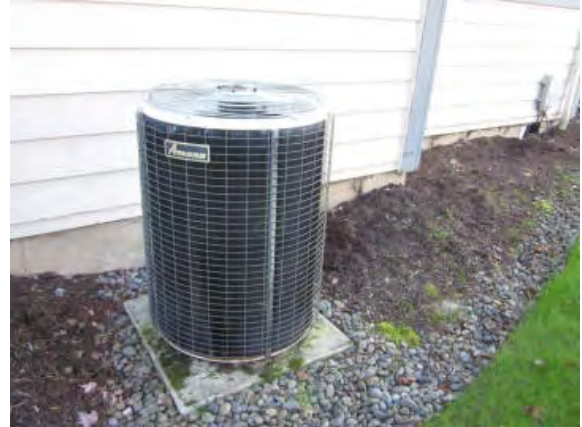
**GENERAL CONDITION:**

This is an old unit and is beyond the typical life expectancy for equipment of this type. The typical condenser is built to last about 12-15 years. This unit is older than that. Have your HVAC contractor review and test the unit's operation and repair or replace it as needed. I did not operate it today. Include it in the review with the furnace.

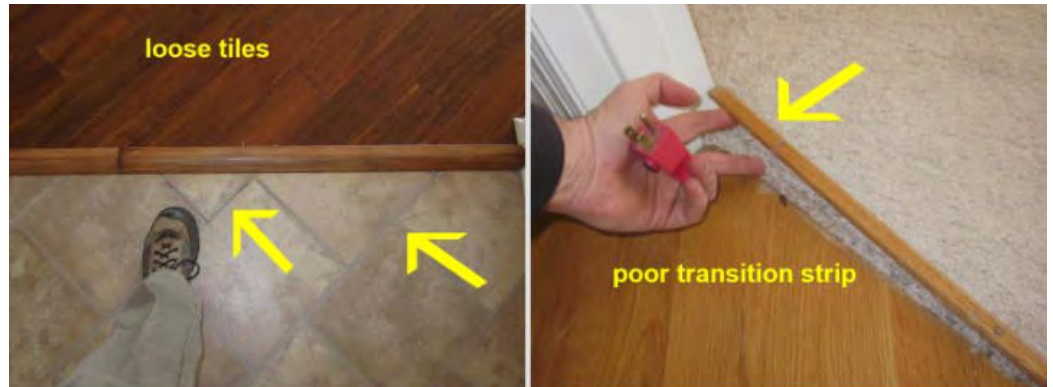
## FLOOR COVERINGS:

- Carpet around master toilet is not properly installed. You should plan to remove the carpet from the wet areas.
- Loose transition strips noted.
- Most of the wood floors installed after construction are amateur installations. This is most obvious in the SW bedroom where there are large gaps between boards and visible face nailing. Repair the flooring as desired.
- The vinyl tiles installed in the kitchen/dining area are loose. You will need to repair/replace this flooring.

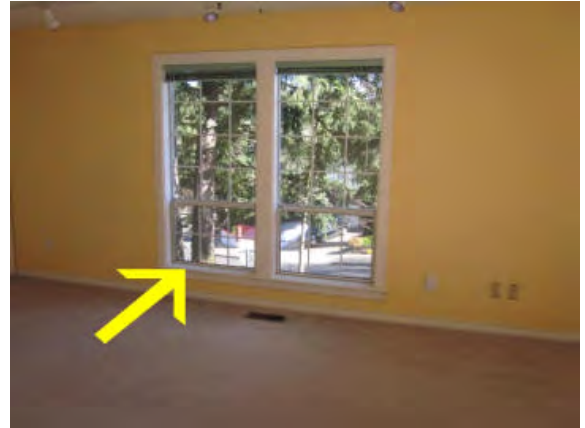
**CAUTION** - The very low sill height at bonus room windows is a potential hazard for children. If these windows are open, a child could easily fall out of the windows, and onto the ground/driveway below. Consider installing guards across the windows for safety.

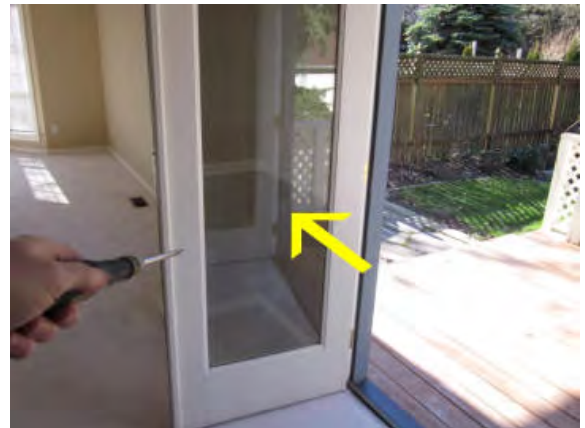
- Failed thermal seals (like the windows) at dining room french doors. Have the glass sections repaired/replaced as needed. Like the windows, the clouding will worsen with time.
- The door knob at the front door, is bent/damage. Repair or replace it as needed.

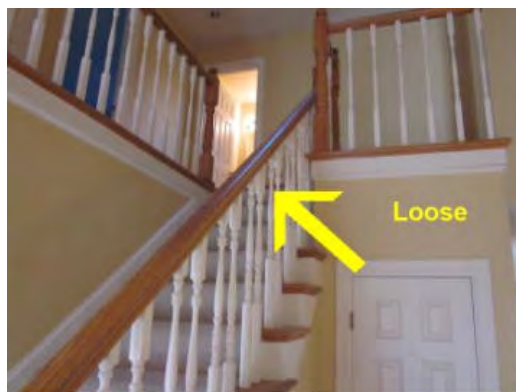
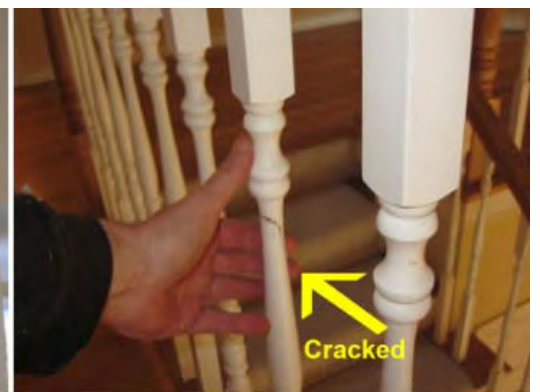
**RAILINGS:**

**CAUTION** -

- The main upper rail section (main stairway) is loose. It needs to be secured properly.
- Some of the balusters are spaced greater than 4 inches apart at some railing areas. Although typical for the era of construction, this large gap between balusters has proven to be a hazard for children. You should have your contractor review and improve the safety of the railings inside and outside the home.
- There is a cracked and very weak baluster in the upper rail. This is hazardous. These type of

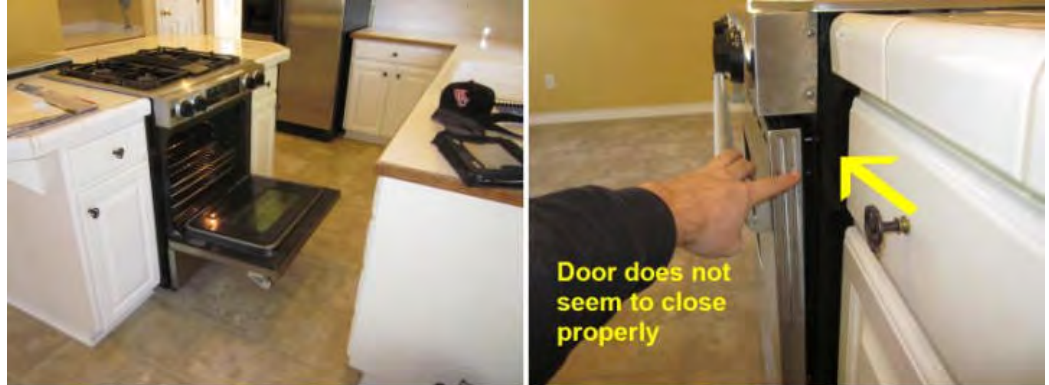
**RANGE/OVEN:**

**CAUTION -**

- The range does not fit in the opening/area properly. There are gaps at the countertop and when the door is open, there is improper access to the oven. This is a potential hazard. Consider reconfiguring the area for improved utility.
- The door appears to be sprung and does not appear to completely close. Contact the manufacturer for recommendation.

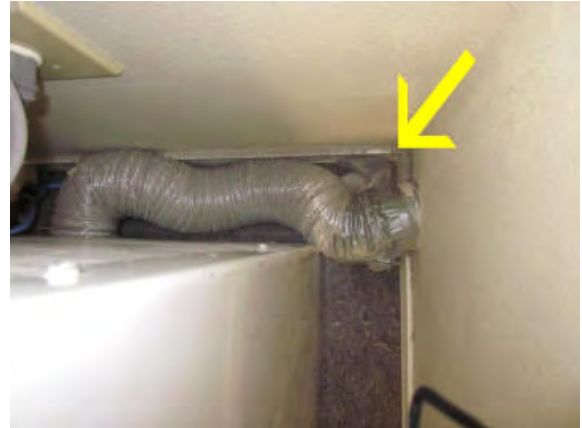
Before using any dryer in the home, have the vents reviewed and repaired for proper and safe operation. An improper vent is a fire hazard.

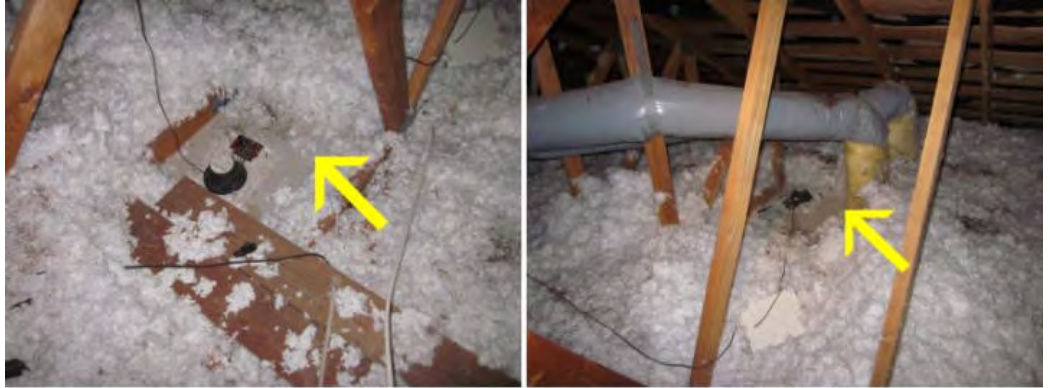
### ATTIC INSULATION:

- The previous owner installed speakers in the master bedroom ceiling. In the attic above this area, the insulation was removed and never replaced. You need to install insulation in this area. Protect the speakers for fire safety.
- A previous owner has traversed the upper attic area to run wiring, resulting in compacted insulation in these areas as well as some missing insulation. You should add more insulation in these worn/missing areas to restore the R-value.

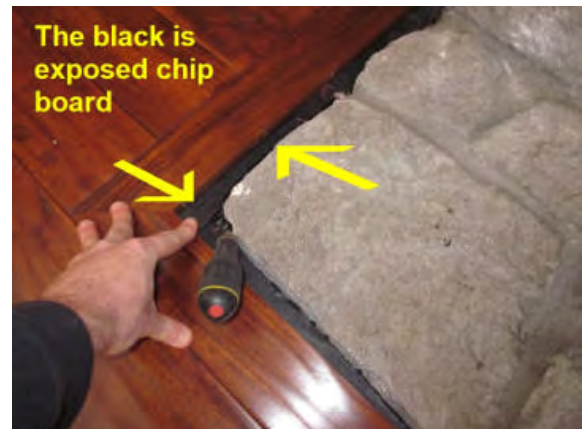
**CAUTION** - The previous owner installed a new hearth and the underlayment edges are exposed to potential embers from the fire. This is a hazard. Have a qualified contractor review and repair the hearth for fire safety. Suggest you do not use the fireplace until the hearth is repaired.
